COLLAPSE POTENTIAL FOR RAILINGS ON BALCONIES

Safety Bulletin – Lessons Learned #1

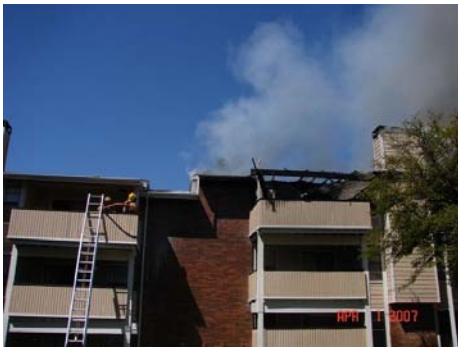
As you can see in the first picture the roof was quickly burned off the building and crews were utilizing the balconies to reach the hotspots along the remaining walls. In order to reach the fire via hose line and pike pole it was necessary to lean out to work effectively from the balcony.

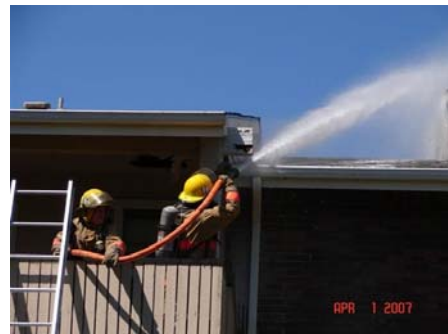
In the second picture you will see a crew using a hose line to lob water into the adjacent burned-out apartment. Although this is often a safe manner of operation if the structure of the building allows it is noted that individuals using the apartment balconies as a work platform trusted that the railing around the edge of the balcony was built solidly and would hold the weight of them and their equipment.

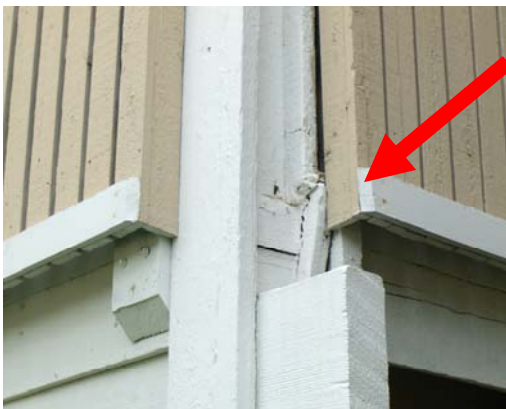
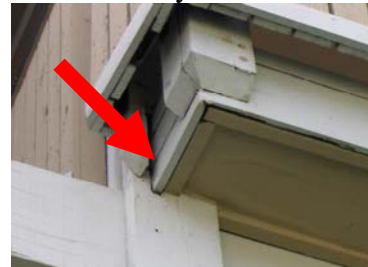
Unfortunately the railings had a number of problems. The units were not built very well to start with and they suffered from years of

deferred maintenance. The railings are only designed to resist a 40-pound side load when they are built.

The existing railings were barely strong enough to stay in place but when a firefighter, with all of the gear that we wear, stressed a railing even more the inevitable happened. The fire was almost out but at 12:53:19 Command sent the message that we all hate to hear; “Firefighter Down.”

What we could have done differently - Mike was quick to mention that trusting the railing was the cause of this accident. As has been discussed earlier this is a common occurrence at fires but it is dangerous due to the poor construction and maintenance of

the railings. A properly set and heeled ground ladder would have provided a good working platform for pulling the fascia board in this instance. We hope that you will consider the condition of any railing before you trust it. Put safety first and we'll all go home at the end of every shift.

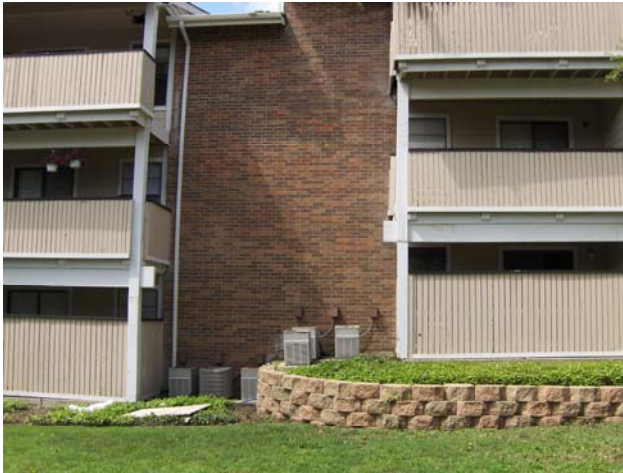
It was a wonder that Mike was not hurt worse than he had been. In the picture to the left you can see the third floor balcony where he was working. When the railing collapsed he apparently tried to jump to the raised flowerbed that was some ten feet away when measured horizontally. Mike landed on one of the air conditioning compressors at the rear of the raised flower bed.

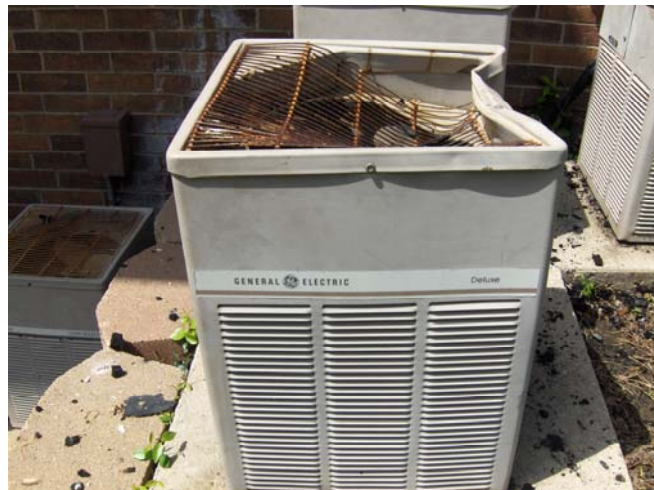
Mike’s feet hit the top of the compressor that you see to the right. The unit absorbed some of the energy from his fall before Mike pitched forward and struck the fence with his head. He spent one day in the hospital and walked out the next day under his own power. He is sore and bruised but Mike Sanford will soon be back to work. His reflexes, superior conditioning, and protective clothing all combined to minimize the effects of a three-story fall.
